# HIGH I/O BGA CONNECTOR SOLDER JOINT INTEGRITY INVESTIGATION

D. Hillman, R. Wilcoxon, K. Cho, J. Sailer, J. Waskow, J. Crawford, T. Wade  
 Rockwell Collins  
 Cedar Rapids, IA, USA  
 ddhillma@rockwellcollins.com

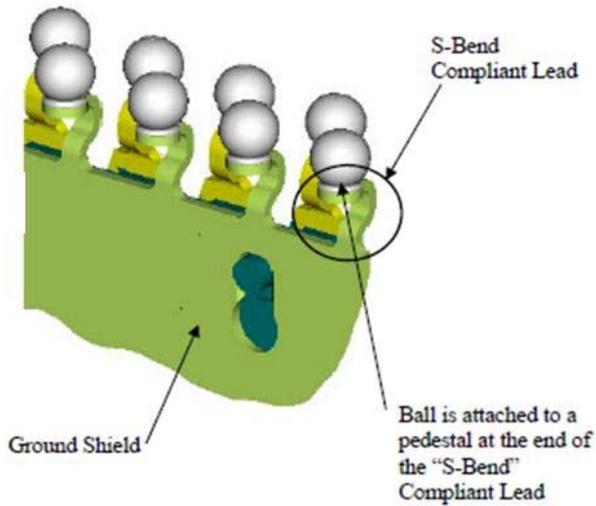
The Amphenol "NexLev" connector utilizes a 'solderball on a spring' for its solder joint interconnect (Figure 1). The rationale for the design is that the compliant lead will act like a spring and reduce solder joint stress.

Figure 1: Amphenol "NexLev" Connector [3]

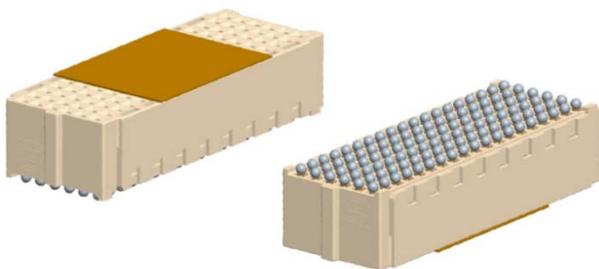
The Mezalok Stacking Connectors are designed to meet or exceed the requirements of XMC2.0 per the VITA 61 standard. The VITA 61 standard defines performance requirements for a rugged, high-speed stacking connector system. These requirements include mating durability of 500 cycles minimum and signal transmission speeds of 5+GHz. The connectors are available in a plug assembly and receptacle assembly that provide a connection between two parallel printed circuit boards. The connectors are available in 60, 114, and 320 positions. The plug has a nominal height of 4 mm and the receptacles are available with nominal heights of 6, 8, 11 and 14 mm (Figure 2).

Figure 2: Tyco Mezalok Stacking Connector [4]

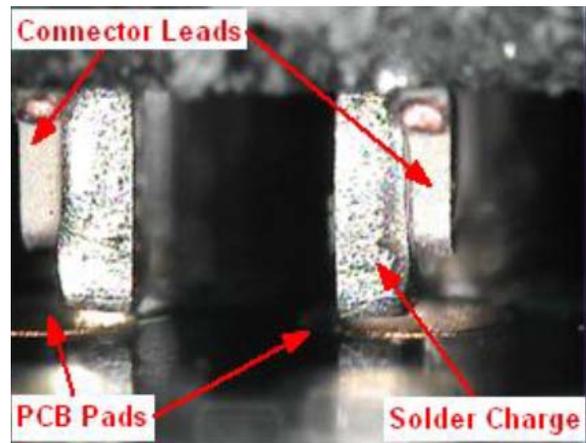
The Samtec SEARAY connector is a departure from the traditional connector configuration due to the inclusion of a solder preform on a blade lead geometry (Figure 3). The purpose of the solder preform is to increase the overall solder joint volume and final solder joint geometry. This high density connector allows for maximum routing and grounding flexibility and allows for speeds up to 18 GHz/pair.

Figure 3: SAMTEC SEARAY Connector [5]

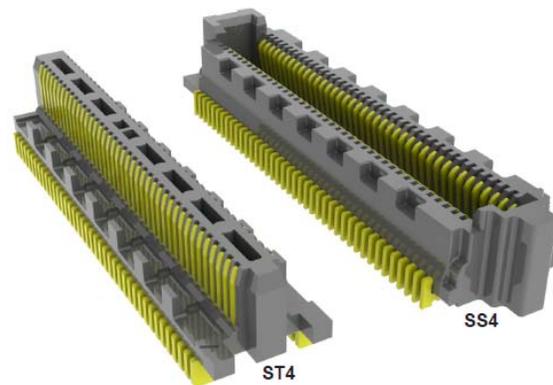
The Samtec ST4 / SS4 series connectors are designed for speeds up to 7.0 GHz / 14 Gbps. The stack heights range from 4.00 mm – 6.00 mm. The connector is illustrated in Figure 4.

Figure 4: SAMTEC ST4 / SS4 Ultra-Fine Pitch Hockey Stick Lead Connector [6]

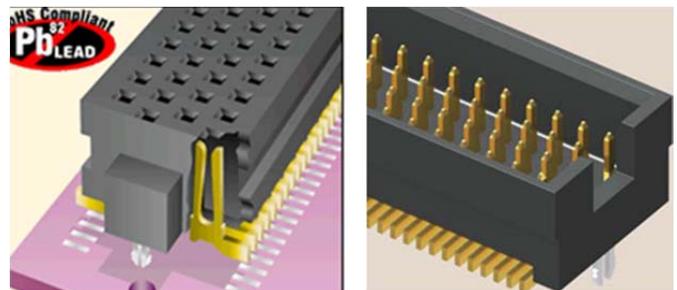
This is a quad row surface mount connector with hockey stick type leads. The connector is illustrated in Figure 5.

Figure 5: Samtec SOLC (left), Samtec TOLC (right) [7]

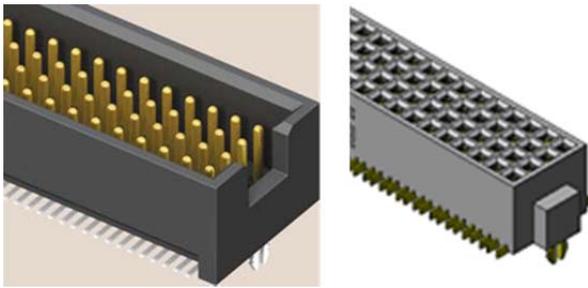
The Samtec MOLC connector is a more traditional configuration with leads in the shape of flat gull wing. The ROLC mating connector has leads resembling the shape of a hockey stick. Figure 6 illustrates the connector.

**Figure 6:** Samtec MOLC (left), Samtec ROLC (right) [7]

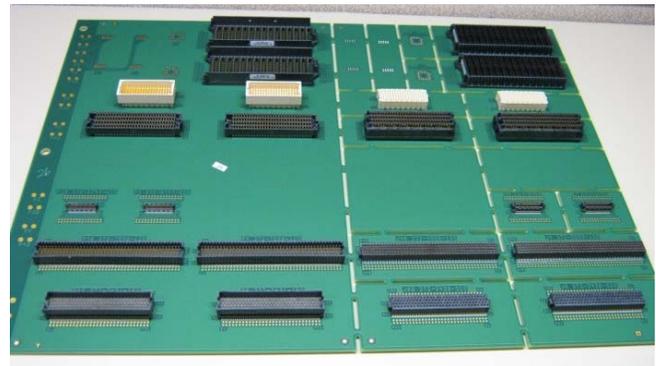
The test vehicle was  $0.079 \pm 0.008$  inches thick with 12 layers. The vehicle was constructed using FR-4 material in accordance with IPC-4101/126 with electroless nickel/immersion gold (ENIG) surface finish. The test vehicle had the mating half of each test connector routed in a break-off coupon to facilitate removal and connector assembly. The pad sizes and stencil apertures used in the DOE, which can significantly impact producibility and reliability, are shown in Table 3. Figure 7 illustrates the assembled test vehicle.

**Figure 7:** As-Assembled Test Vehicle

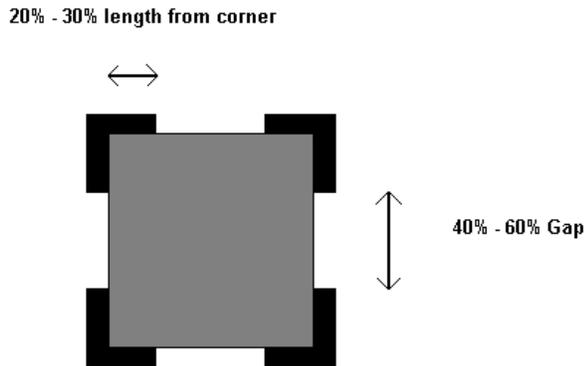
solder joints. Traditional underfill materials could not be used with these connectors due to potential wicking of material into the connector contacts. The edgebond material was applied with a 0.023 inch needle for the hockey stick connectors and a 0.047 inch needle for all other connectors. After application, the edgebond material was cured for 30 minutes in a 130°C oven. Figure 8 illustrates the adhesive coverage, which extended 20% - 30% from any corner of part and left an opening of 40% - 60% along the side of the part.

**Figure 8:** Edgebond Material Perimeter Coverage

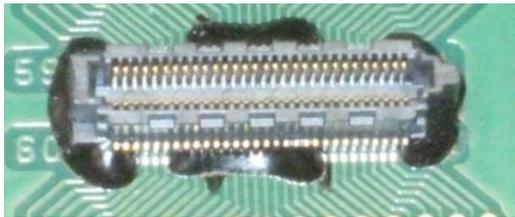
Figure 9 illustrates an example of the UA2605-B material after edgebond material processing.

**Figure 9:** Example of Edgebond Applied to a Connector

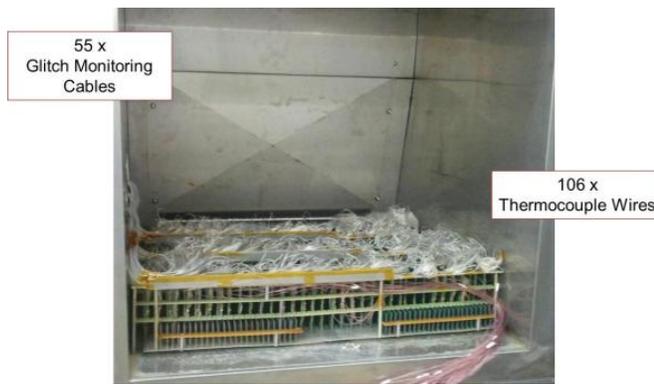
Test vehicles were arranged into a custom test fixture inside the thermal chamber and the cables were fed through a port in the chamber wall to the GDS-1024T Glitch Detector System (Figure 10). The GDS-1024T is a Rockwell Collins custom-designed and built fault detection system.

**Figure 10:** Thermal Cycling Test Vehicles with Cables and Thermocouples Attached

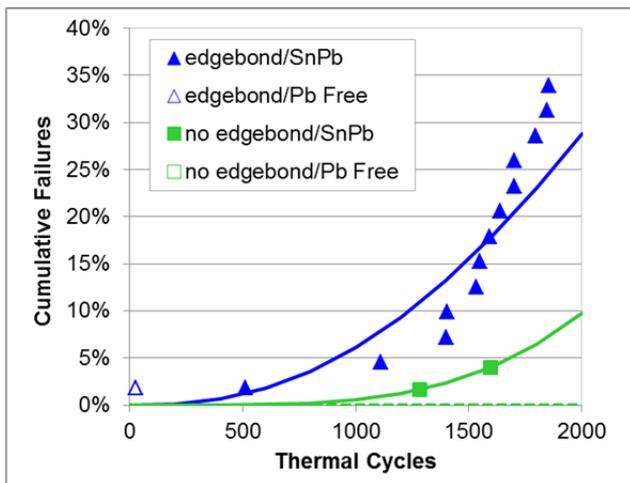
The Amphenol “NexLev” connector demonstrated good performance in the thermal cycle testing for both the SnPb and Pb Free solder processes (see Figure 11 and Table 5). The connectors without edgebond were actually more reliable than those with edgebond. The Pb Free connectors without edgebond had no failures recorded while the SnPb connectors had only 2 failures, for an overall failure rate after 2000 cycles of less than 5%. The Pb Free connectors with edgebond had only one early failure that appears to be an outlier while the SnPb connectors with edgebond did exhibit a number of failures starting at 512 cycles with an N63 of more than 3000 thermal cycles.

Figure 11: Amphenol “NexLev” Connector Failure Plots

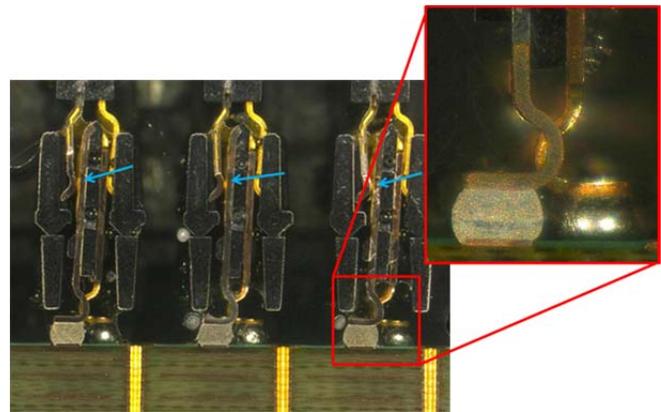
Previous testing [8] had documented conflicting statistical analysis and physical failure results for the Amphenol “NexLev” connector. Root cause analysis demonstrated that this was likely due to the connector contact interface “chattering” during thermal cycle testing, which causes the computer monitoring system to register a “false open” for solder joint cracking/failure. Figure 12 illustrates a cross-sectional view of the connector and the interface locations in which chatter led to problems in earlier testing. This failure root cause was avoided during this investigation by instituting a seating/reseating of the connector interfaces on a specific interval schedule. Figure 13 shows cross-

Figure 12: NexLev Connector Contact Interface (Arrows Indicate Interface “Chatter” Location) [8]

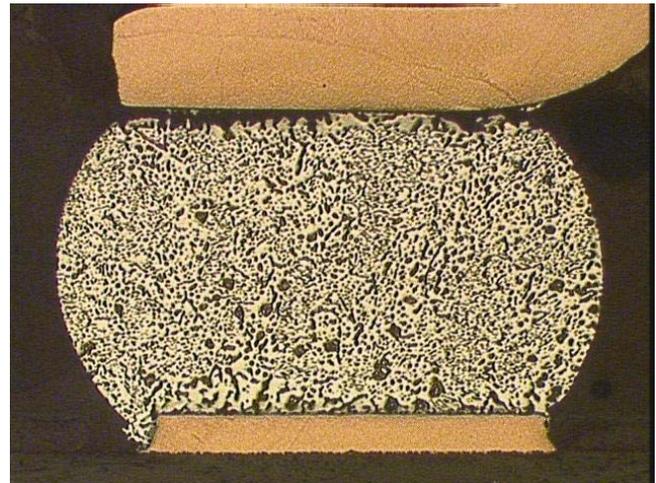
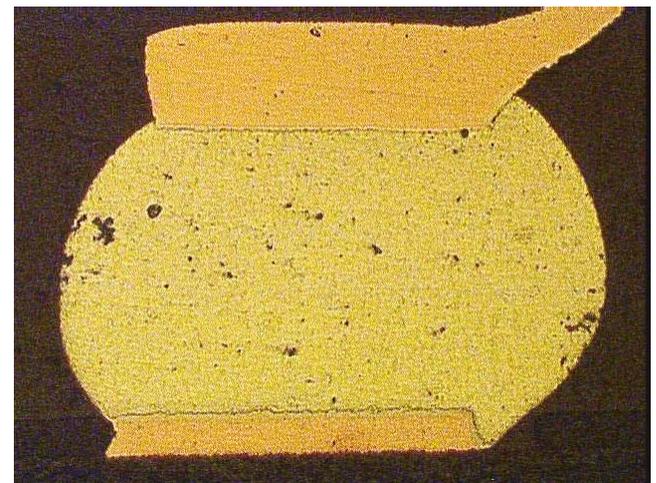
sectional views of the connector solder joints from the current testing that demonstrated acceptable solder joint integrity. Solder joint microstructure coarsening and some solder joint cracks due to the impact of the thermal cycling were observed, especially in the SnPb joints.

Figure 13: NexLev Connector, Typical Solder Joints, SnPb (top), Pb Free (bottom)

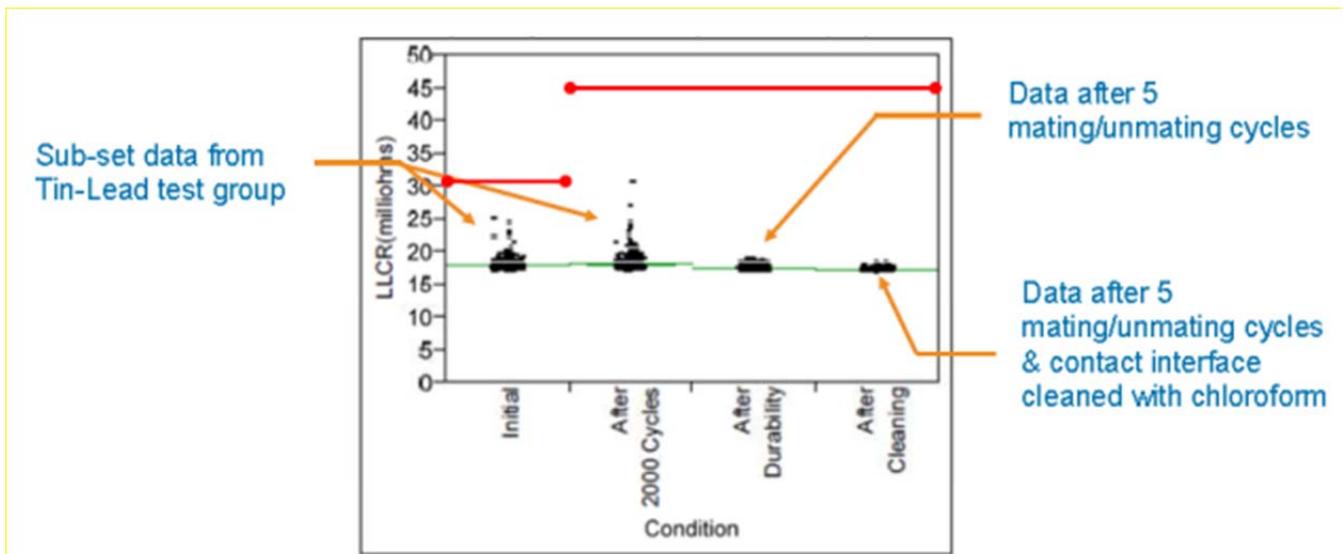
An independent confirmation of the performance of the Mezalok connectors was completed during the investigation. Tyco representatives, following Rockwell Collins recommendations of solder joint integrity testing per the IPC-9701 specification, completed 2000 thermal cycles from -55°C to +125°C with no failures [9]. Tyco's testing also confirmed that the Rockwell Collins "chattering" test issue was a result of the connector contact interface motion and not a solder joint integrity issue. Figure 14 illustrates how Tyco was able to eliminate suspected solder joint integrity issues after 2000 thermal cycles by cleaning the contact interfaces.

**Figure 14:** Mezalok BGA Connector Data Demonstrating Impact of Connector Interface on Solder Joint Integrity Measurements [9]

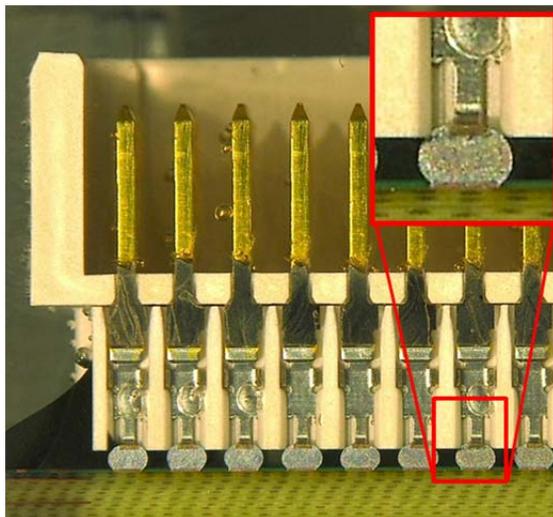
Figure 15 through Figure 17 illustrate the cross-sectional views of the Mezalok Stacking connectors after 2007 thermal cycles. Some regions of solder joint microstructure coarsening is apparent after completing the thermal cycle testing in the SnPb solder joint.

**Figure 15:** Mezalok Stacking Connector

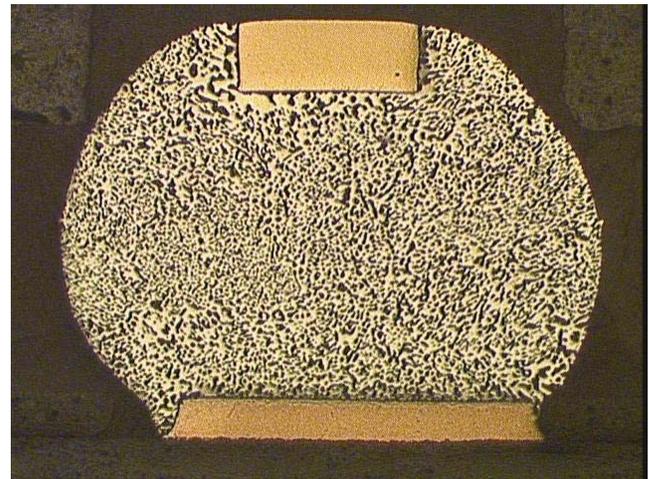
**Figure 16:** Mezalok Stacking Connector, Typical Solder Joints, SnPb Alloy

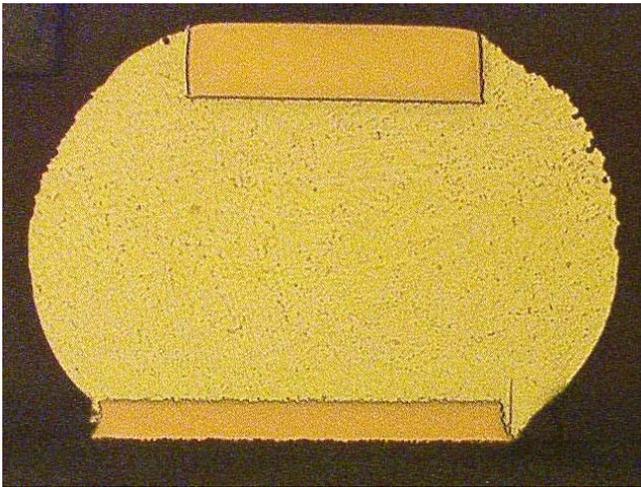
**Figure 17:** Mezalok Stacking Connector, Typical Solder Joints, Pbfree Alloy

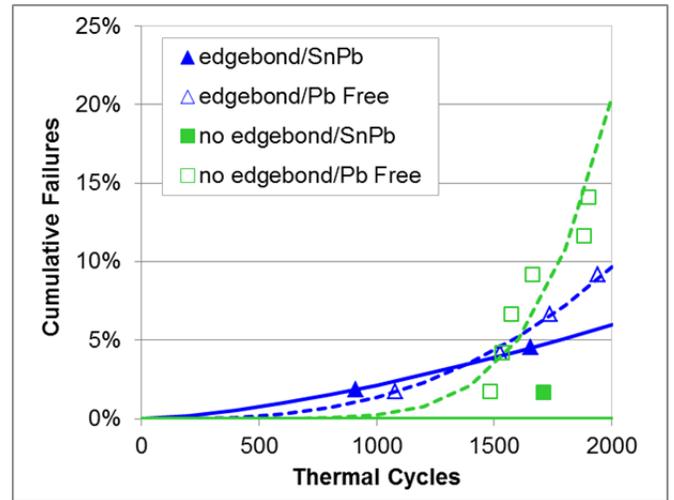
The SAMTEC SEARAY connector exhibited excellent SnPb and Pb Free thermal cycle performance (Table 7 and Figure 18). Only 3 failures out of a population of 79 connectors were observed for the SnPb configurations while the Pb Free configurations had 10 failures out of a population of 80 components with only two failures before 1500 thermal cycles. Edgebonding of the connectors did improve the average life of the connectors, however this improvement does not appear to be significant and the edgebonded connectors did suffer earlier first failures than the connectors with no edgebond. Therefore, the use of edgebond on these connectors does not appear to be an effective method for ruggedization. As with the “NexLev” connector, previous testing [8] had documented conflicting statistical analysis and physical failure results for the SEARAY connector due to the connector contact interface “chatter” phenomenon. Again, the procedure of seating/reseating of the connector interfaces eliminated the issue during this testing sequence. Figure 19 - Figure 21 illustrate the solder joint cross-section observations. Some minor solder joint microstructure coarsening is apparent and there is some cracking around the Pb Free solder joint “eye of the needle” resulting from thermal cycling.

**Figure 18:** SEARAY Connector Failure Plots

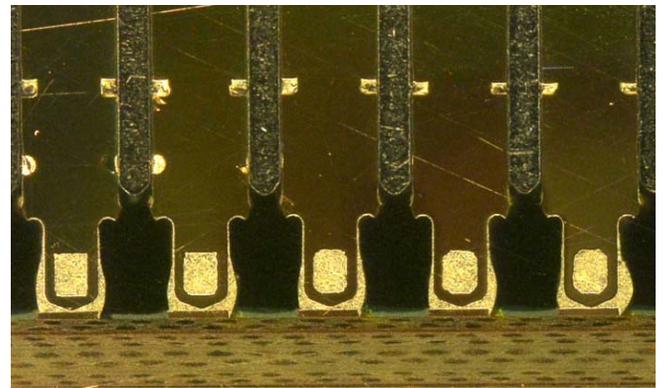
**Figure 19:** Macro View of SEARAY Connector, Sn/Pb Solder Process

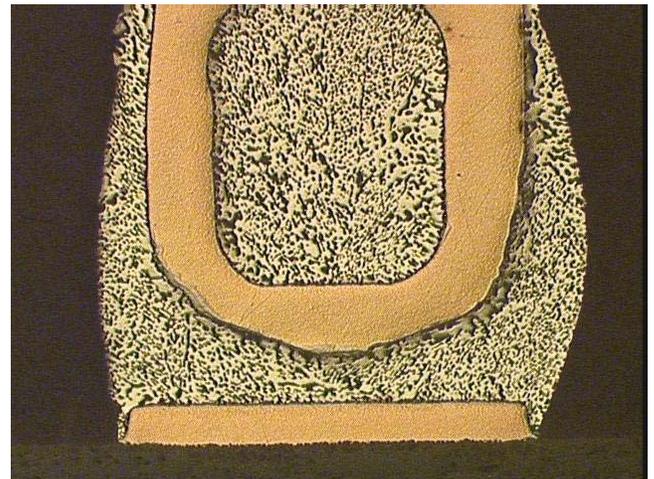
**Figure 20:** SEARAY, Typical Solder Joints, SnPb Alloy

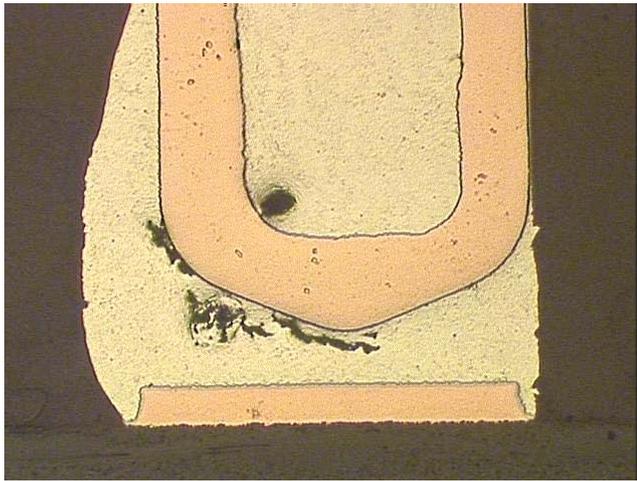
**Figure 21:** SEARAY, Typical Solder Joints, Pb Free Alloy

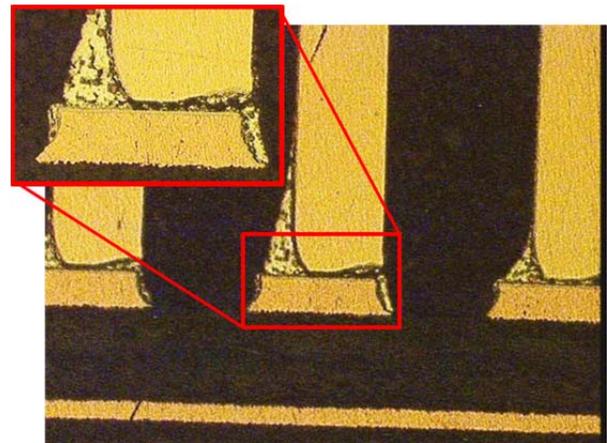
Figure 23 and Figure 24 illustrate the SST/SS4 solder joint microstructures observed. Significant microstructure coarsening is present and the connector lead-to-pad alignment is poor, particularly with the SnPb solder. Additionally, the solder joint volumes are minimal as some of the solder volume is distributed up the connector lead rather than being located at the connector lead/pad interface.

**Figure 23:** ST4/SS4 Connector, SnPb, Failed @ 227 Cycles

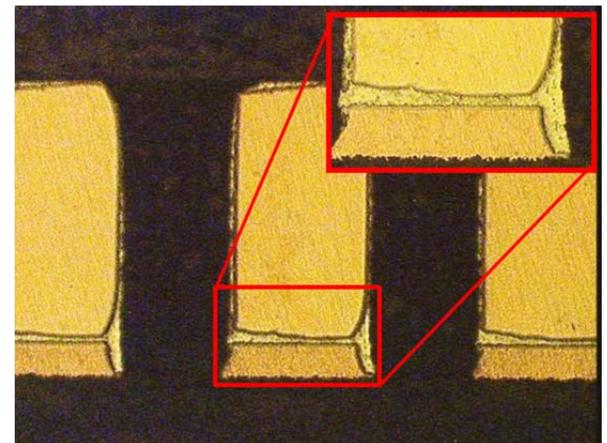
**Figure 24:** ST4/SS4 Connector, Pb Free, Typical Solder Joint

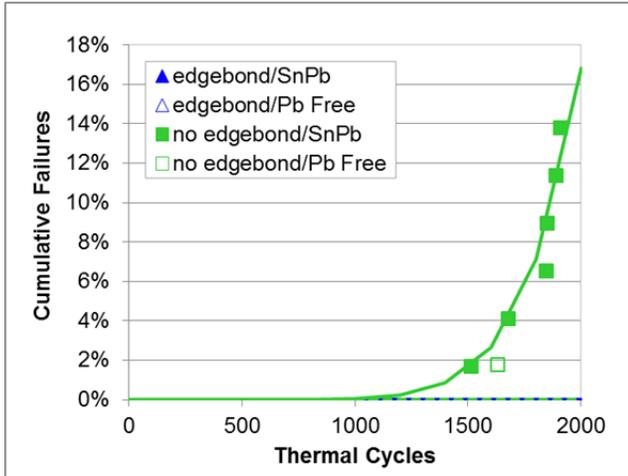
The TOLC/SOLC connectors exhibited good thermal cycle solder joint integrity results (Figure 25 and Table 9).

Only the SnPb connectors with no edgebond had sufficient failures to determine Weibull parameters and none of these failures occurred before 1500 thermal cycles. The investigation used a new pad geometry for the TOLC/SOLC connectors relative to earlier Rockwell Collins studies; this change is presumably responsible for the highly reliable performance observed with these results.

Figure 25: TOLC / SOLC Connector Failure Plots

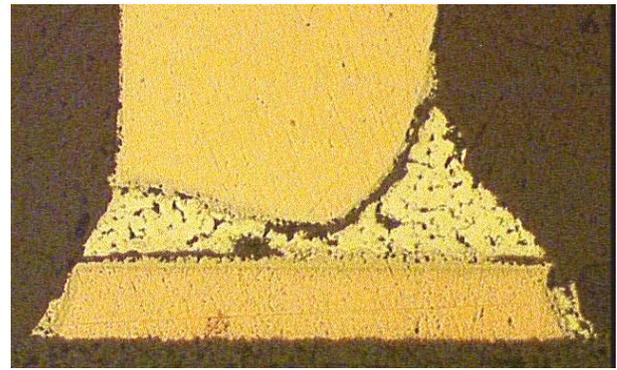
Figure 26 shows solder joint microstructures of a failed component with a crack within the solder joint. Figure 27 shows a Pb free connector solder joint, that was not damaged by the thermal cycling. In both of these cross-section views, it is evident that the solder joint volume is distributed up the connector negatively impacting the solder joint integrity.

Figure 26: TOLC/SOLC Connector, SnPb, Failed @ 1515 Cycles

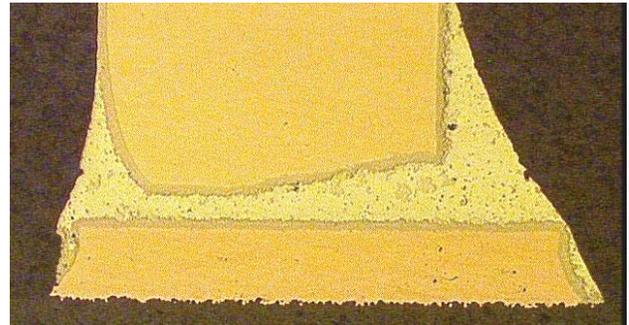
Figure 27: TOLC/SOLC Connector, Pb Free, Typical Solder Joint

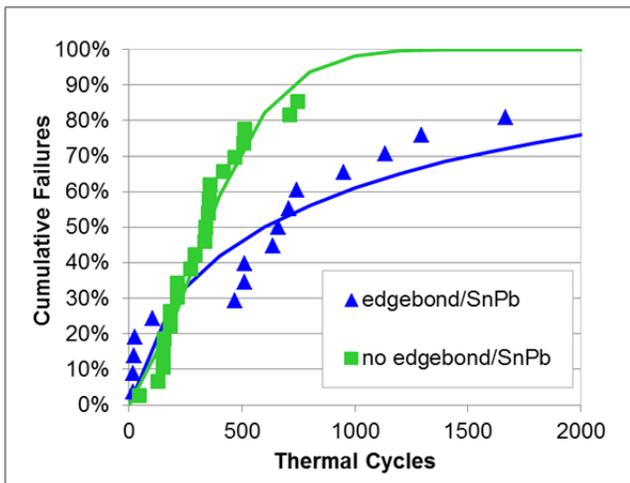
Figure 28 illustrates the failure results for the MOLC / ROLC connector (note that no Pb Free configurations were included in the investigation for this connector). This connector by far showed the poorest solder joint integrity during testing with more than half of the components failing by 500 cycles. The use of edgebond slightly improved the overall reliability of the population, but also appeared to introduce a number of early infant mortality failures that occurred before 100 thermal cycles. The Weibull coefficients, which are shown in Table 10, exhibit low beta values that correspond to inconsistent assembly that leads to infant mortality failure.

Figure 28: MOLC / ROLC Connector Failure Plots

This inconsistent build is at least in part due to the extremely poor manufacturing yield of the MOLC / ROLC connector that led to the need to rework multiple solder joints on each connector. This extensive rework confounded the test results since it was not clear whether the subsequent poor reliability during thermal cycling should be attributed to the connectors or to the rework processes. The producibility challenges encountered in assembling the investigation test vehicle build are reflective of the same issues that occur when these connectors are used on production assemblies. Regardless of whether the poor solder joint integrity was due to the connectors or the rework process, these test results indicate that this connector style is not generally suitable for Rockwell Collins avionics applications.

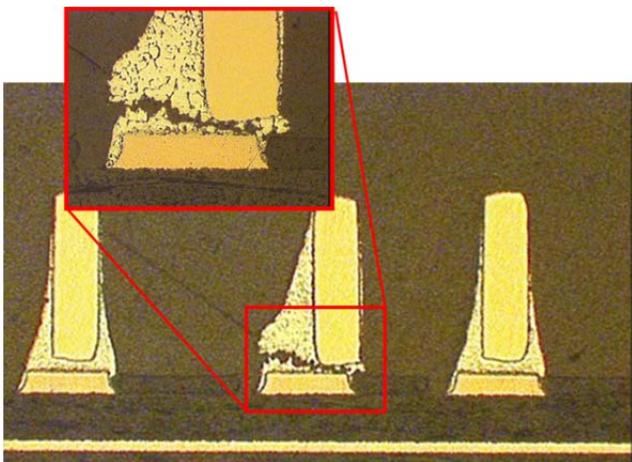
Figure 29 shows cross sections of a typical failure of a MOLC/ROLC connector. The solder exhibits significant coarsening and cracking despite the comparatively early failure (638 cycles) relative to the life of other connector families evaluated in this study. This indicates the existence of severe local stresses at the solder joints with minimal stress relief provided by the hockey stick lead.

Figure 29: MOLC/ROLC Connector, SnPb, Failed @ 638 Cycles

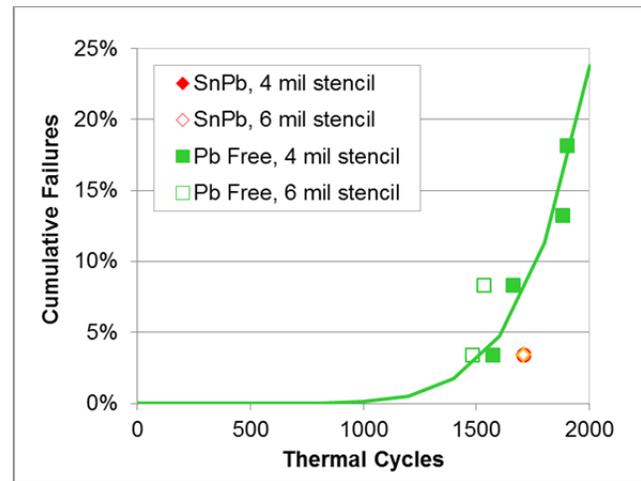
BGA and Hockey Stick connector solder joint integrity could be assessed. Industry literature and internal Rockwell Collins opinions varied greatly on the degree to which solder joint integrity could be improved with the use of a thicker stencil to increase the overall solder volume. Test results from this study showed that the solder stencil thickness had minimal effect on the solder joint integrity for either the BGA or the Hockey Stick style connectors used in the testing. Figure 30/Figure 31 and Table 11 illustrate the investigation results for stencil thickness impact on solder joint integrity.

Figure 30: SEARAY Connector - Impact of Stencil Thickness Results

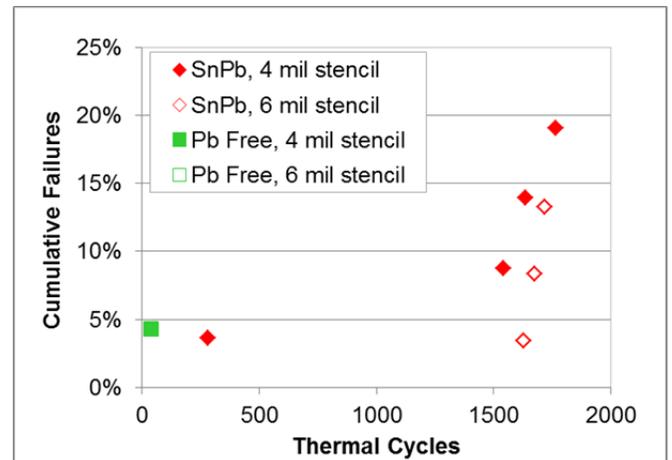
Figure 31: Hockey Stick Style Connectors (all groups) - Impact of Stencil Thickness Results
